SAO 1.2m Primary Mirror Monthly Report

March 19, 2012

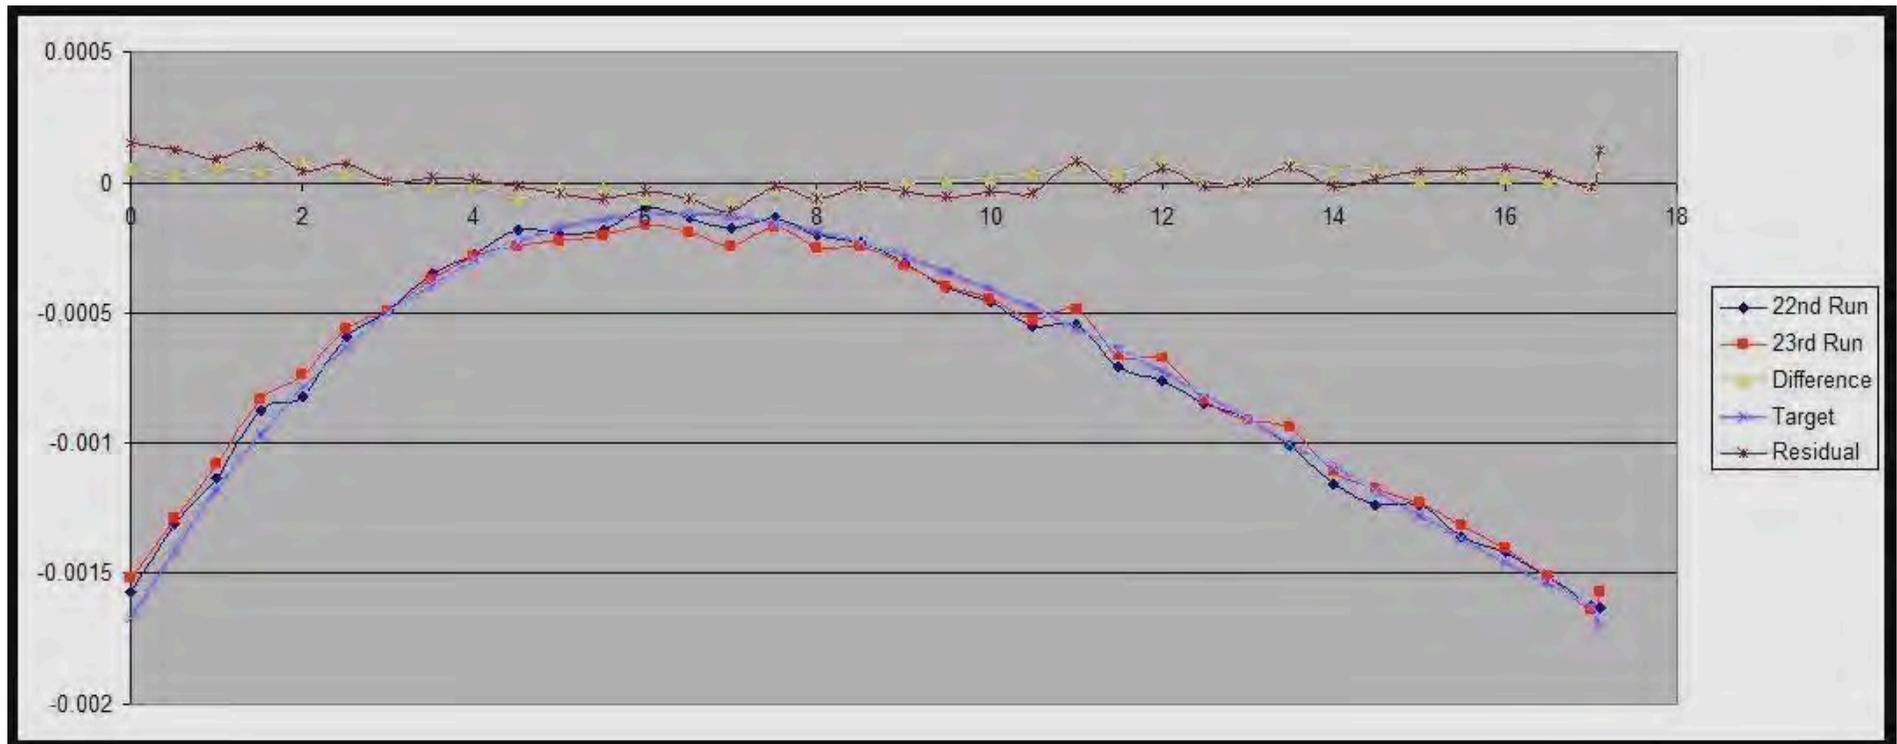
- Latest results are in the chart below.
- Last grinding run has occurred and the results are shown below.

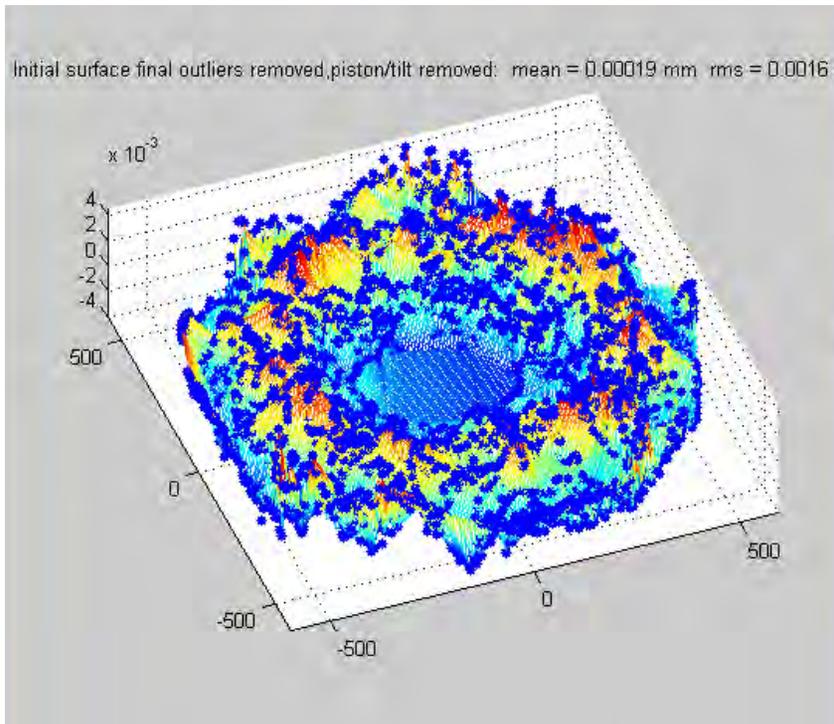
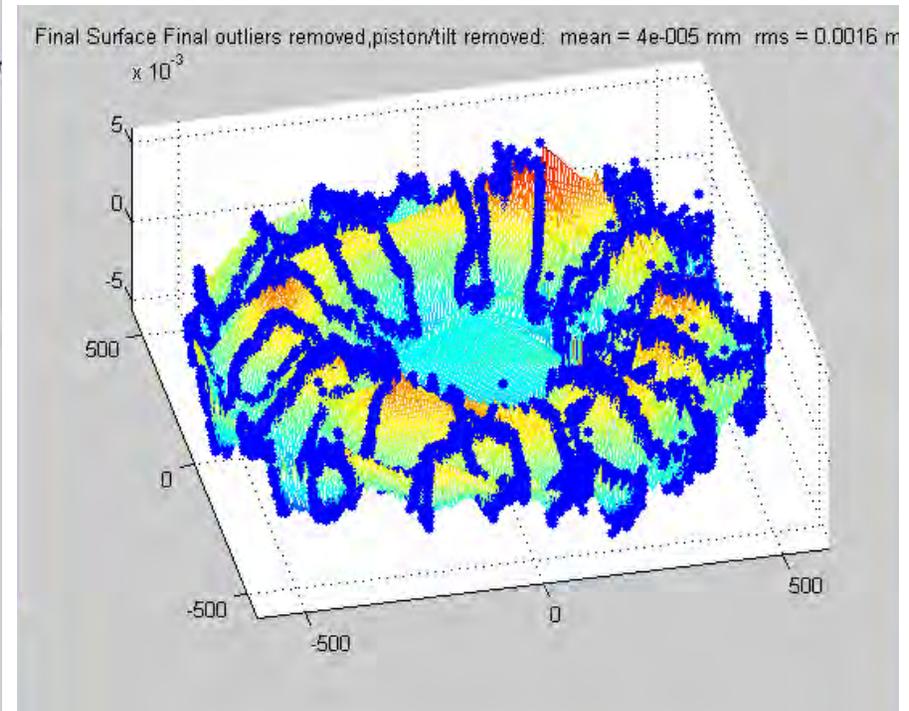
Laser Tracker Test (nominal conic and RoC)

- The 9 micron grinding is now completed and polishing has begun.
- A laser tracker measurement was made to confirm radius and conic is acceptable at this *stage* (see page 5 & 6 for details).

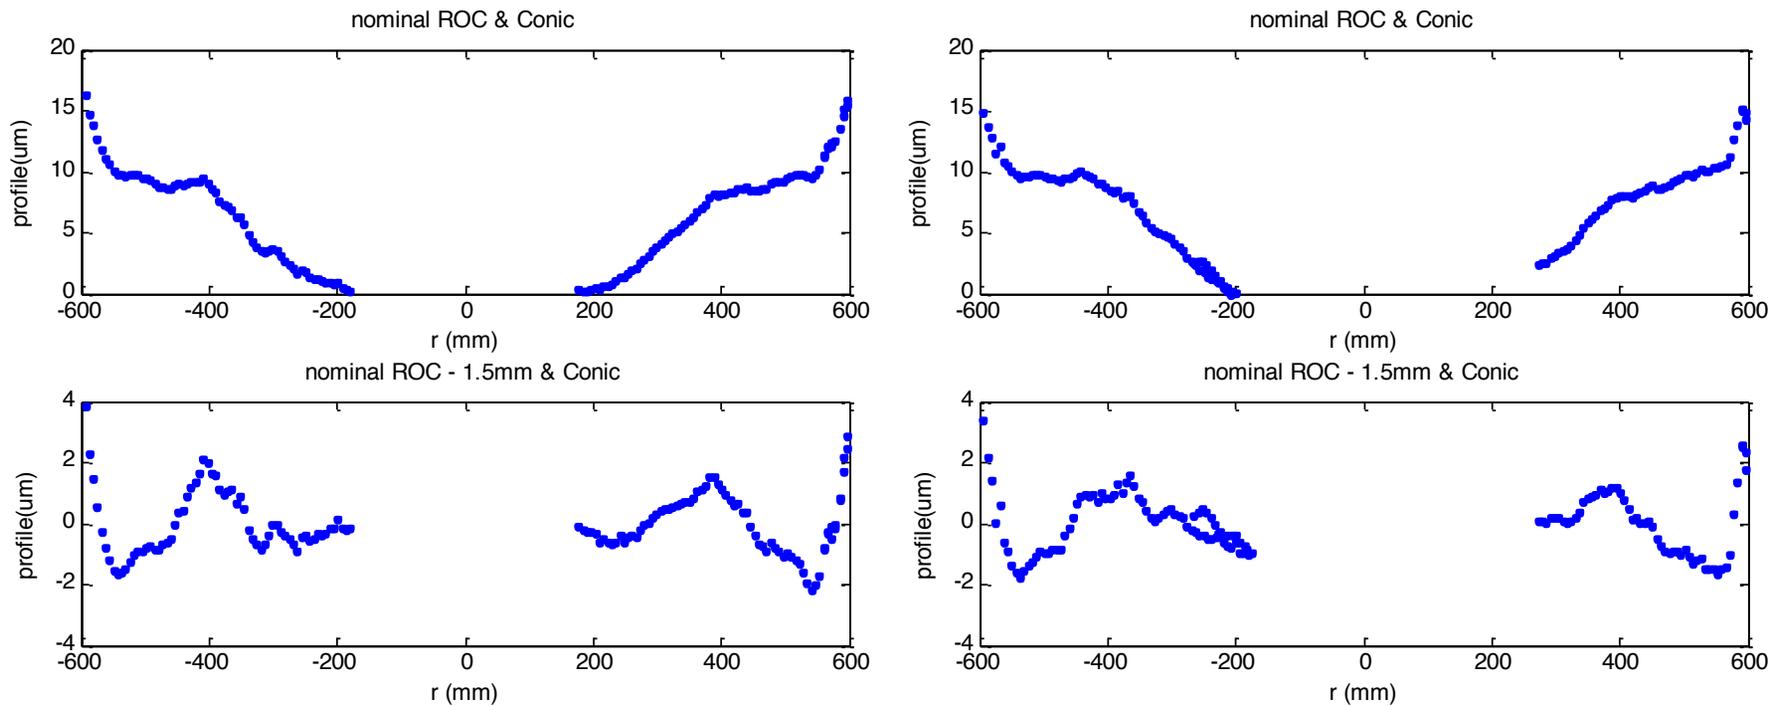
*X and Y scan with
Nominal ROC(4590.87mm) & Conic(-1.040231)*

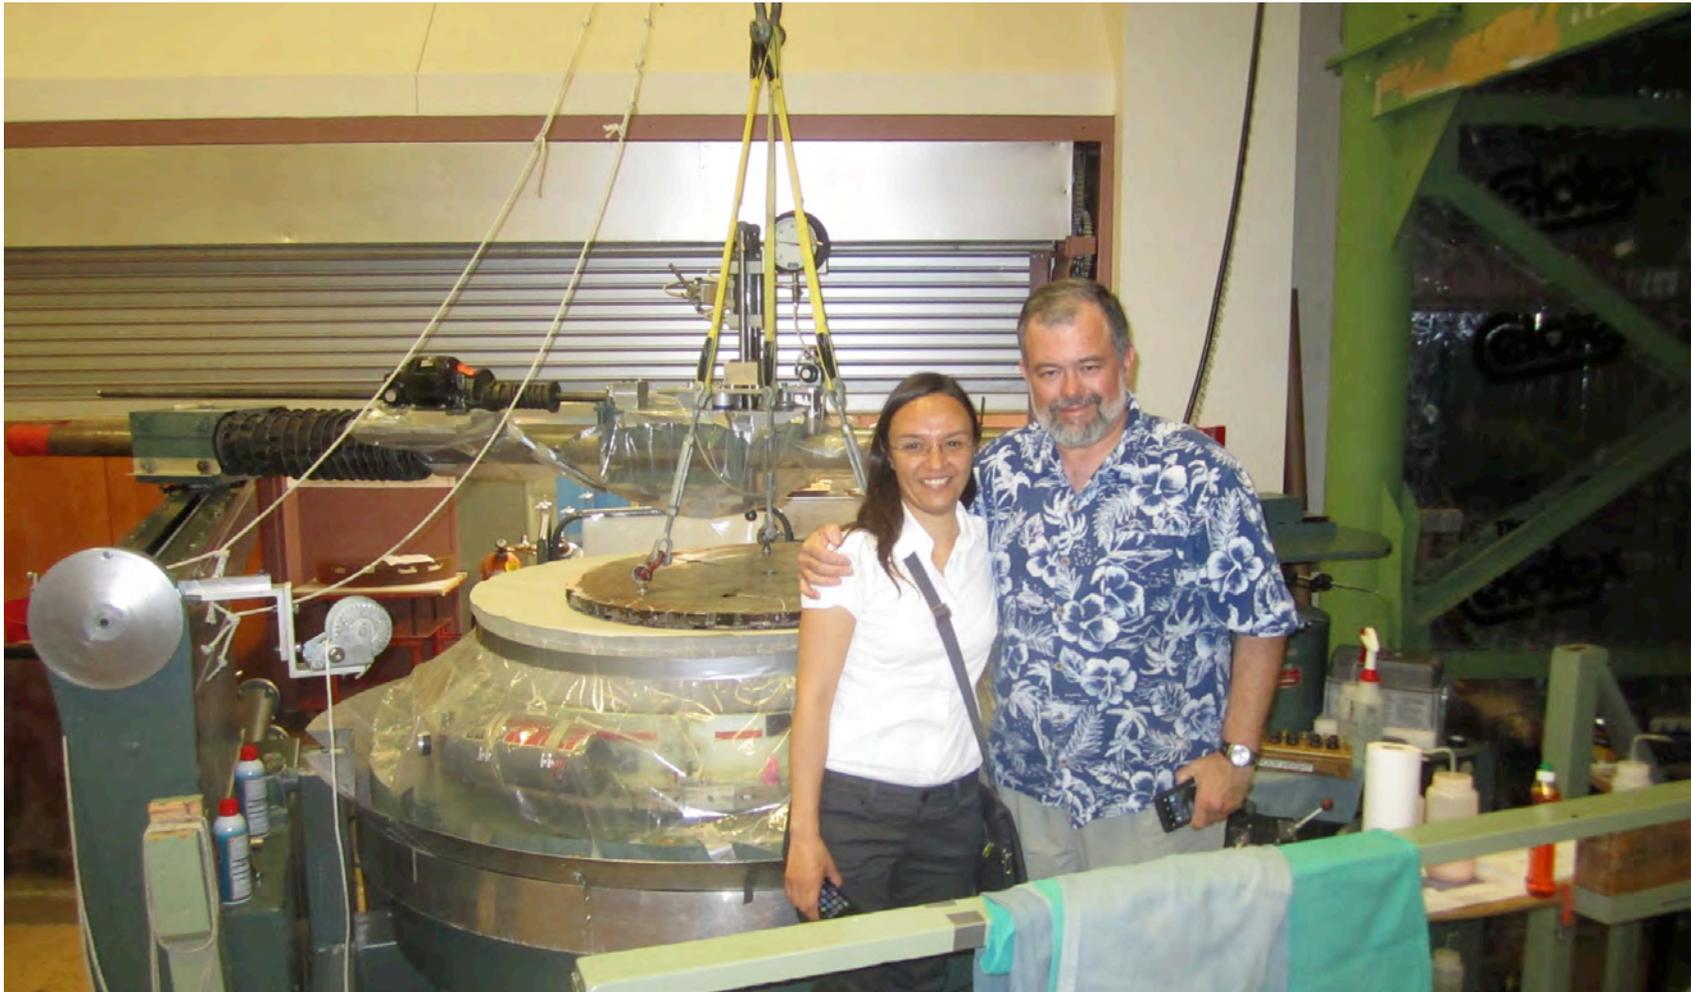
Photographs I.

SAO 1.2m primary mirror after a polishing run on April 17, 2012.

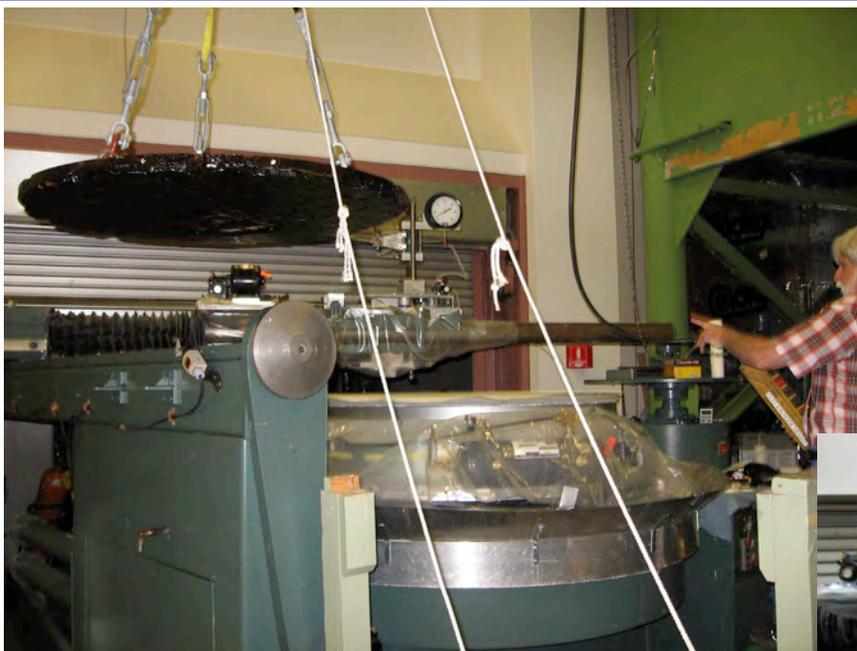
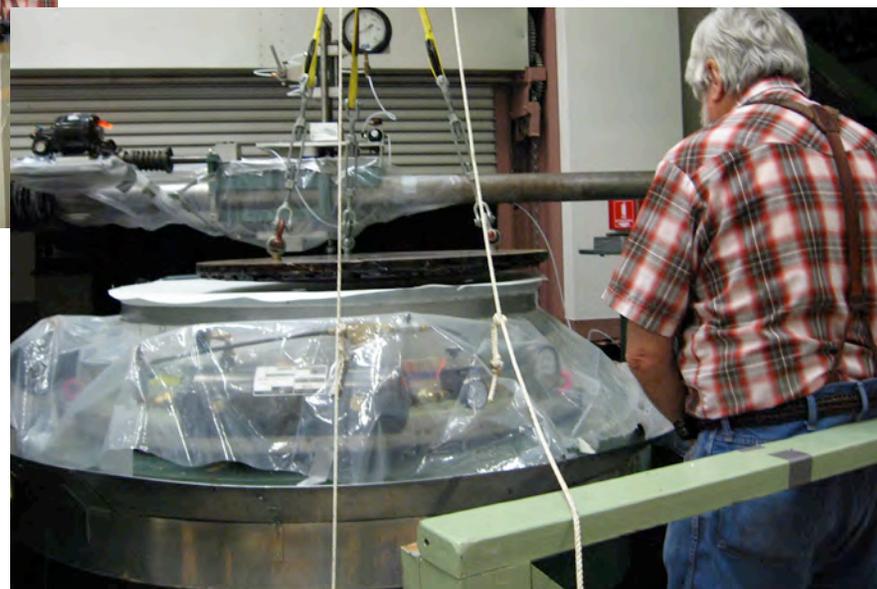
Photographs II.

New polishing lap being put on the mirror to be pressed-out prior to the first polishing run.

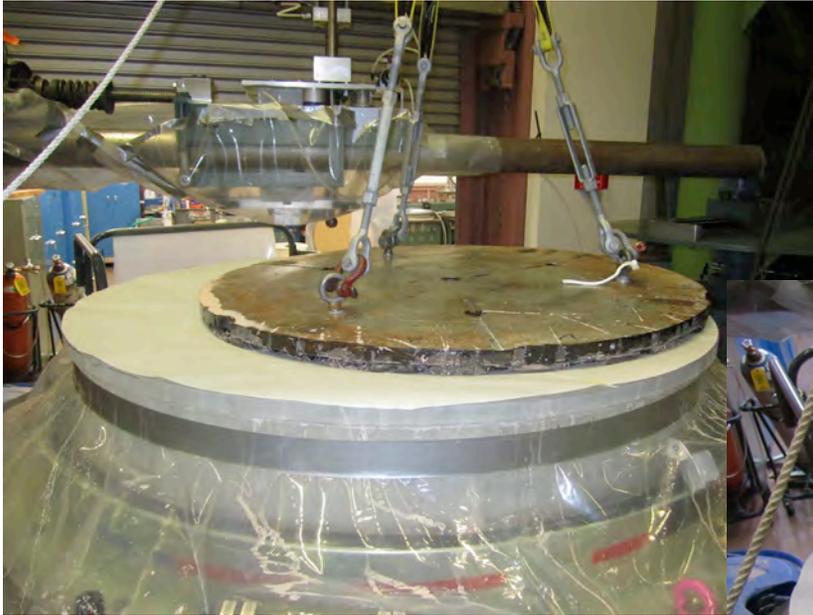
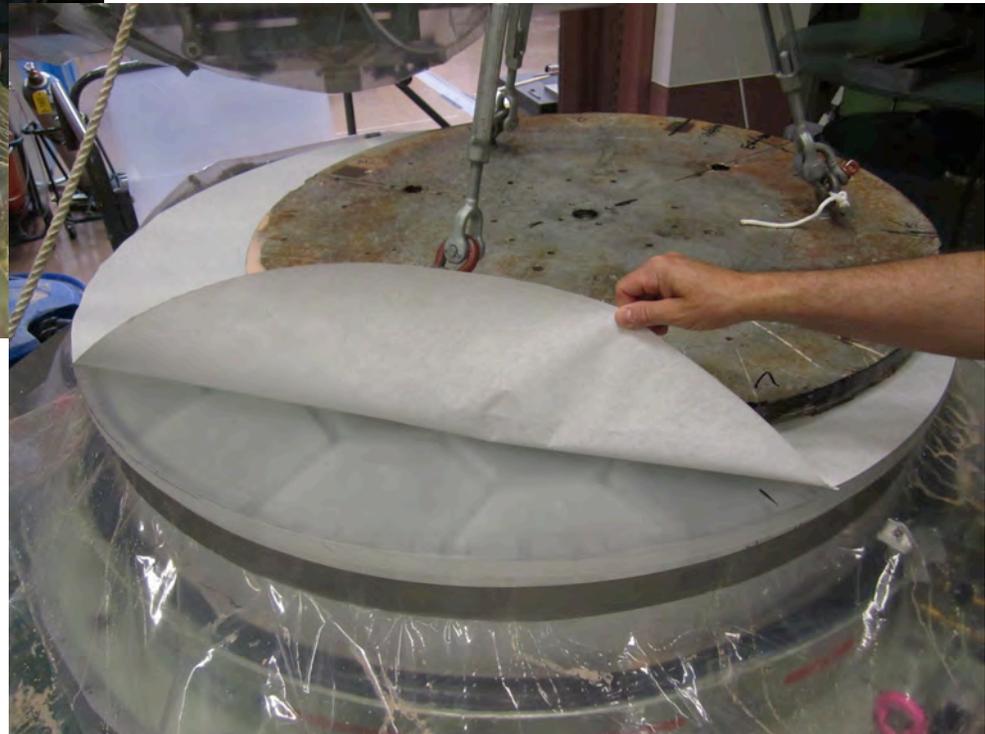
Photographs III.

Polishing tool on mirror after the first polishing run.

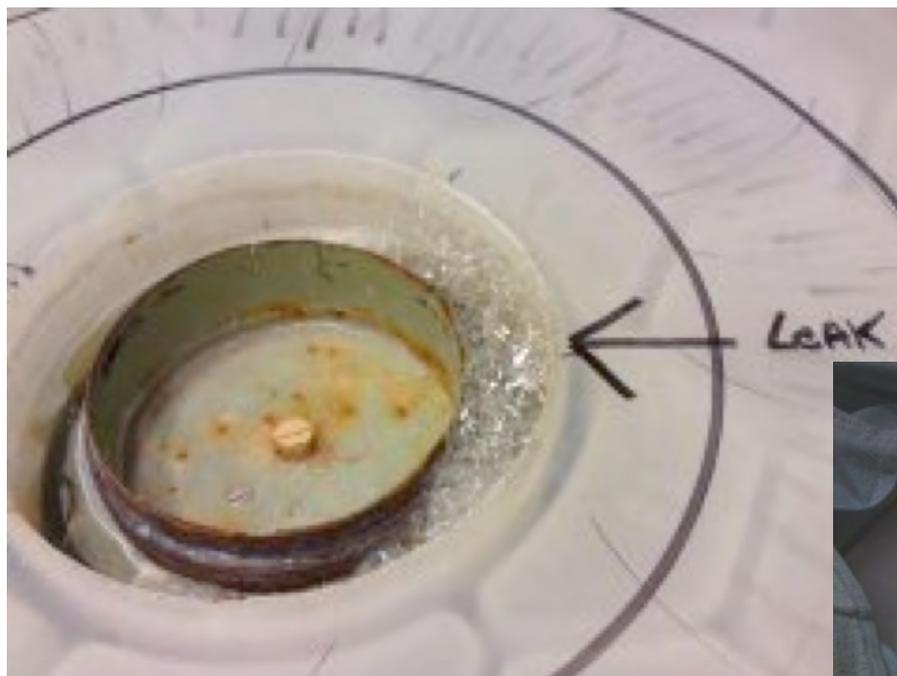
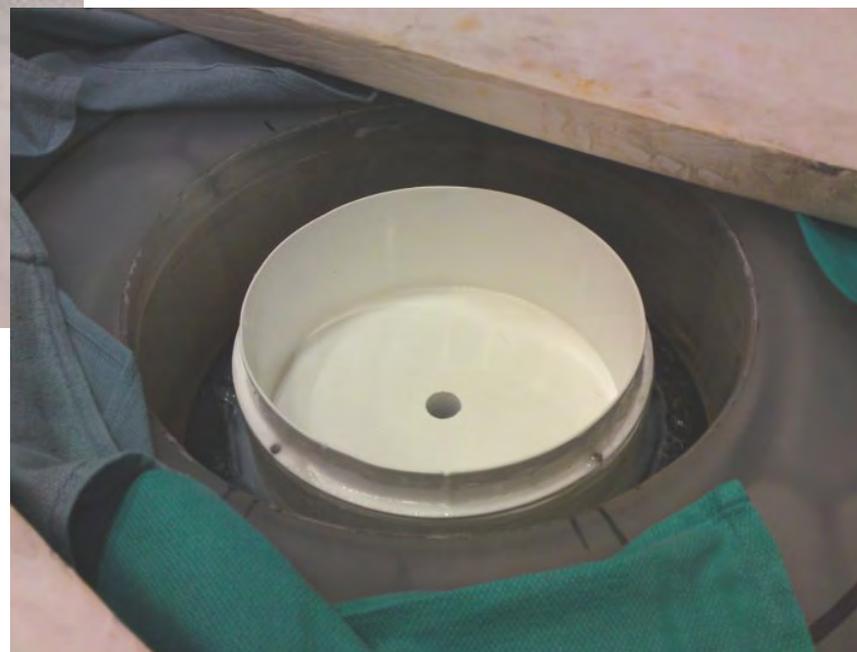
2. Pictures Photographs IV.

- Parts are being fabricated for a SCOTS test that will be used to guide the early polishing work.
- The center hole of the cell started leaking (see page 9). Once inspected it became clear the steel center plug had rusted at the seal and was leaking. The part was yellow zinc and had rusted through at the location of the seal. The part was replaced with a powder coated surface and the cell is now working. A little more than a week was lost as a result of this failure.

The center hole seal leak due to corrosion. The part was replaced, powder coated and installed.
